Fronius Galvo 1.5-1 – 3.1-1 208-240

USB update *fro28171.upd*

Software versions:

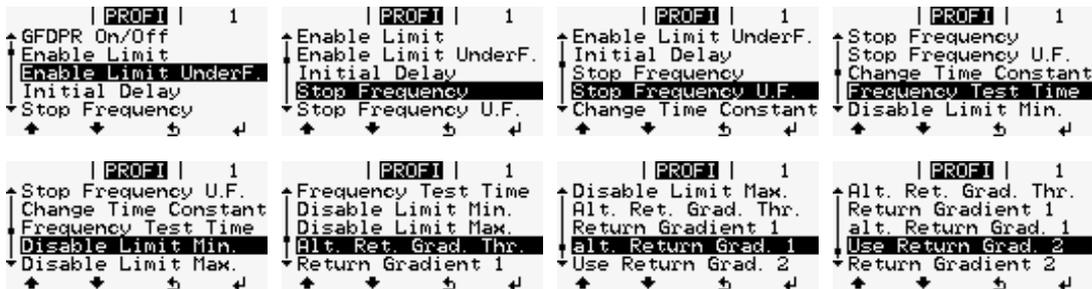
- Extension of the P (f) settings for the GDPR function by the following parameters:
Start frequency at underfrequency
Stop frequency at overfrequency
Stop frequency at underfrequency
Frequency Test Time (Duration of frequency monitoring before return to nominal power)
Disable Limit min (lower limit for frequency monitoring)
Alternative Return Gradient Threshold (Percentage drop of nominal power, from which “Alternative Return Gradient 1” is activated)
Alternative Return Gradient 1 (Alternative return gradient to maximum power in %/s, based on the difference between frozen and lowest power)
Use Return Gradient 2 Mode (Mode: 0 ... ‘Return Gradient 1’ or ‘Return Gradient 1 Alternative’ is used, 1 ... ‘Return Gradient 2’ is used)
Return Gradient 2 (Further return gradient to the maximum power in %/s, based on nominal power, if this is activated)
